## *Is electrolysis eating your boat?*

*By Nick Walker.*

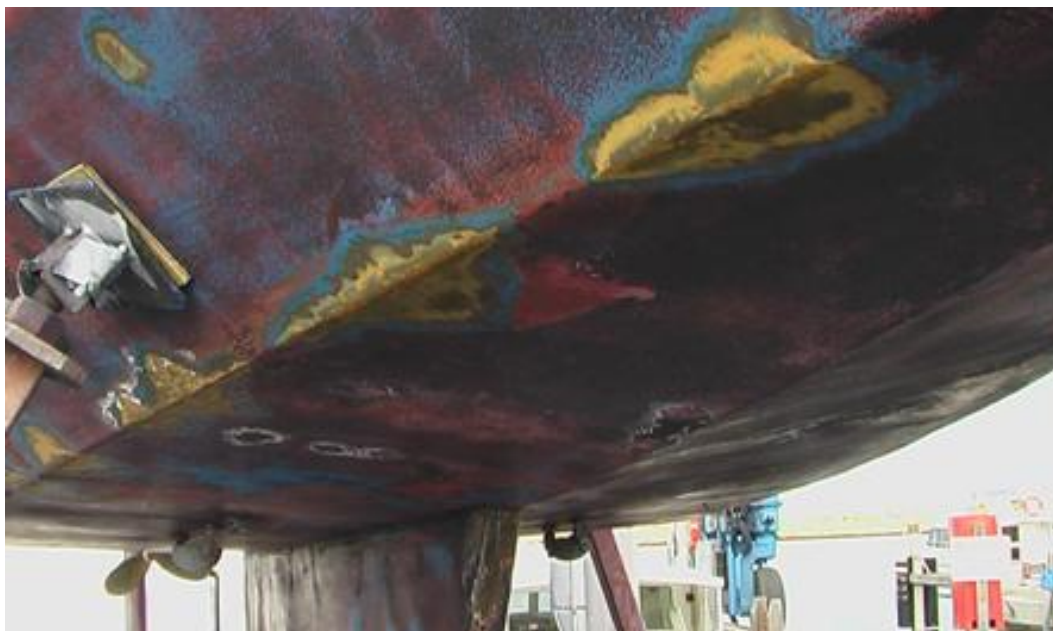
*Paint blistered off along weld lines and other random spots.*

My problem manifested itself by blistering the paint below the water line. When the blisters were removed the metal below them was bright and shiny, not rusty. This is because the electrolysis process caused the formation of a weak hydrochloric acid to form between the metal of the hull and the paint on it. This can be caused by having too many anodes fitted, which is what a couple of people suggested to me, so I reduced the number of anodes on my boat to no avail. I also noticed small amounts of my bronze propeller disappearing. I put up with this for 3 years, spending lots of time and money fixing the blistered paint each lift out only to have the same problem the following year.

With my boat I found 2 faults in the “house” wiring which were easily fixed and then turned my attention to the motor.

The other is to fit isolating switches between the batteries and the motor that can be used to totally electrically disconnect the motor from any source of voltage while not in use.

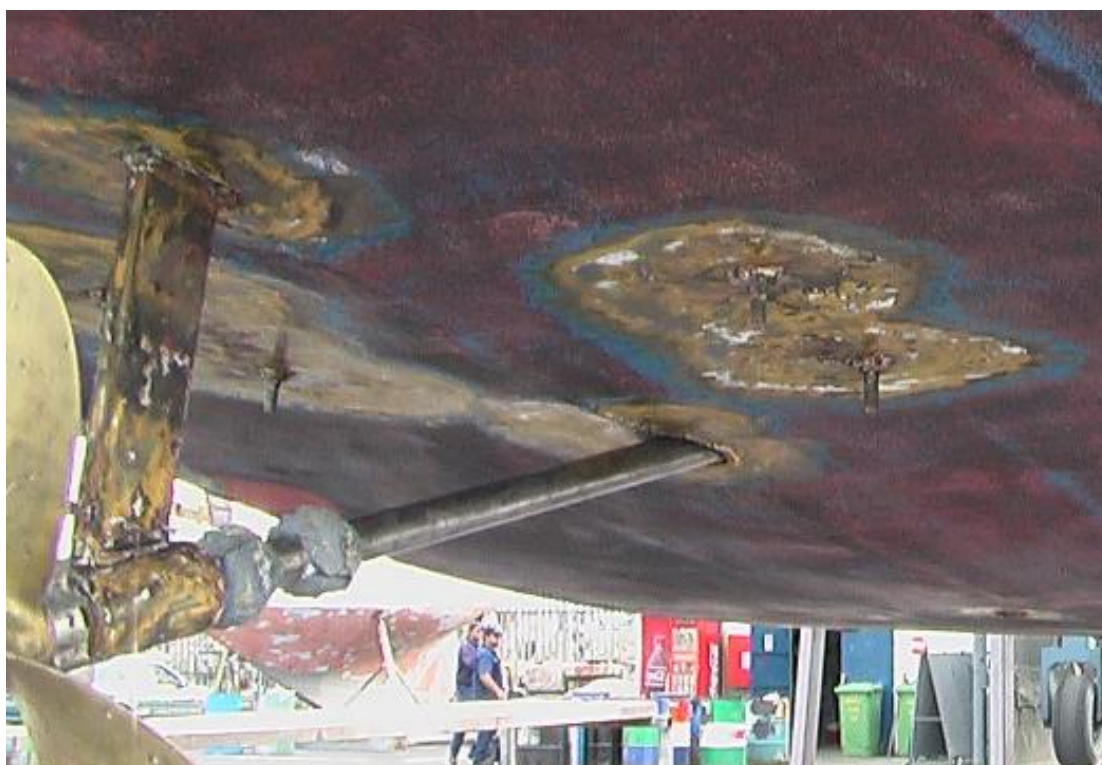
*Paint blistered off around anode bolts, stern tube and P bracket*

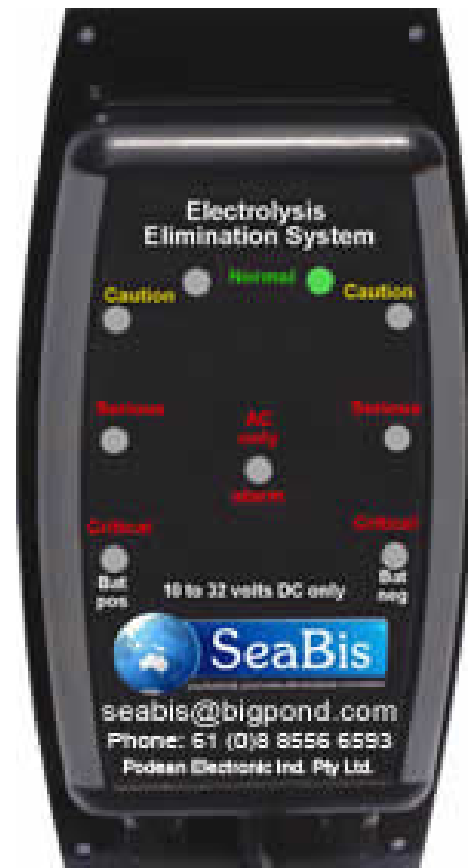
As a die-hard DIY person I started checking out options on the internet. After much reading I stumbled across a device called Seabis. This device connects to your boat, a wire to each battery terminal and one to “wet metal” meaning any metal part of the vessel that is normally submerged. It uses an inbuilt microprocessor to detect any current flow between your battery and your metal bits (hull, shafts etc) and give you an indication of how serious the problem is.

*The Seabis  
unit*
